PANTHER **VS** SHERMAN

Battle of the Bulge 1944

STEVEN J. ZALOGA

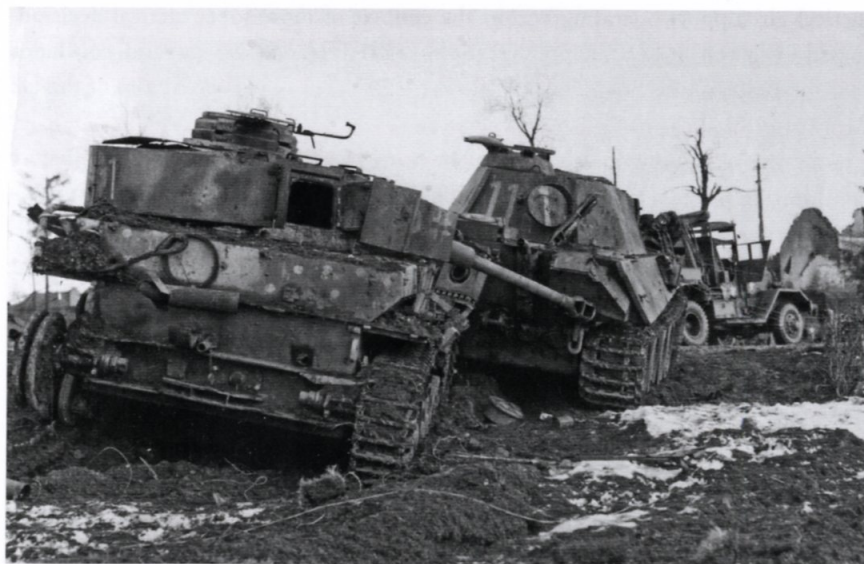
After nearly reaching the Meuse River, the vanguard of the 2. Panzer Division became trapped in a pocket near Celles, Belgium and overwhelmed by the US 2nd Armored Division. Here, the US Army retrieves an abandoned PzKpfw IV and Panther Ausf. G; the division's trident emblem is visible on the rear of the PzKpfw IV. [NARA]
